ATHENA POWER

Detroit Edison Sensor Pilot
Data Analysis 2022

Pilot Overview

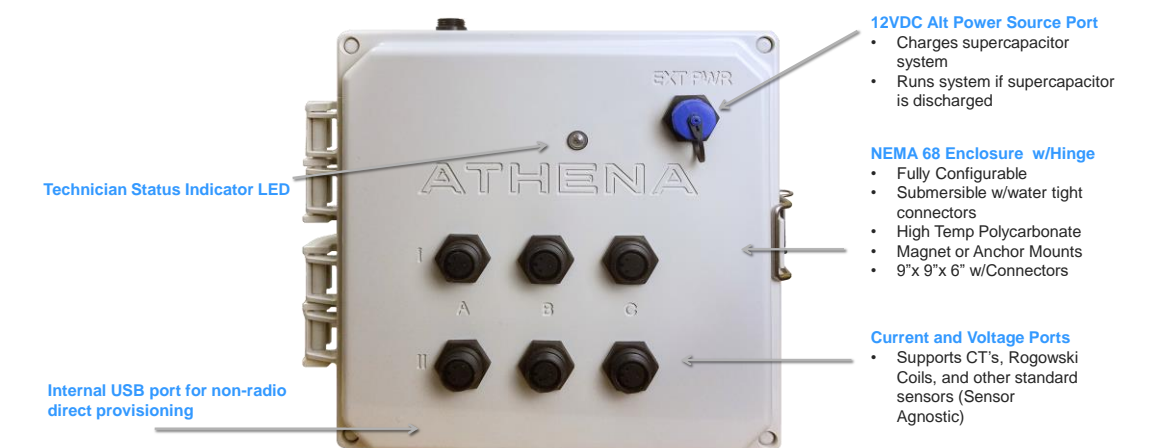
The sensors were custom developed for DTE and were primarily oriented for fault detection. The sensors are three-phase oriented with power harvesting technology and direct DNP3 output. Cellular connectivity (utilizing the Sierra Wireless RV 50) were equipped on each Athena UFD Sensor. Custom Antennas and cables were developed for the netbank asset class to demonstrate strong connectivity and uptime

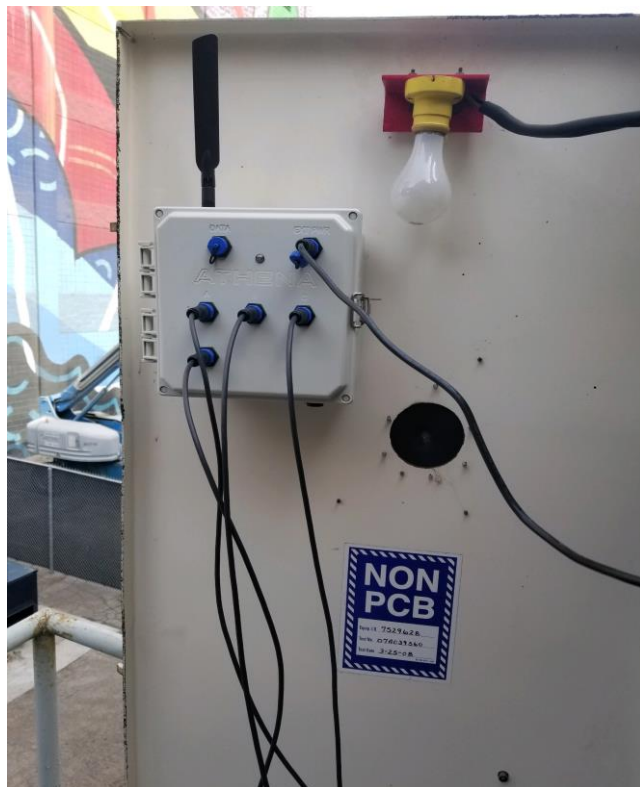
Netbank Installation

Three-phase Current + Neutral was installed on netbanks throughout downtown Detroit. Secondary Power was used to power the unit

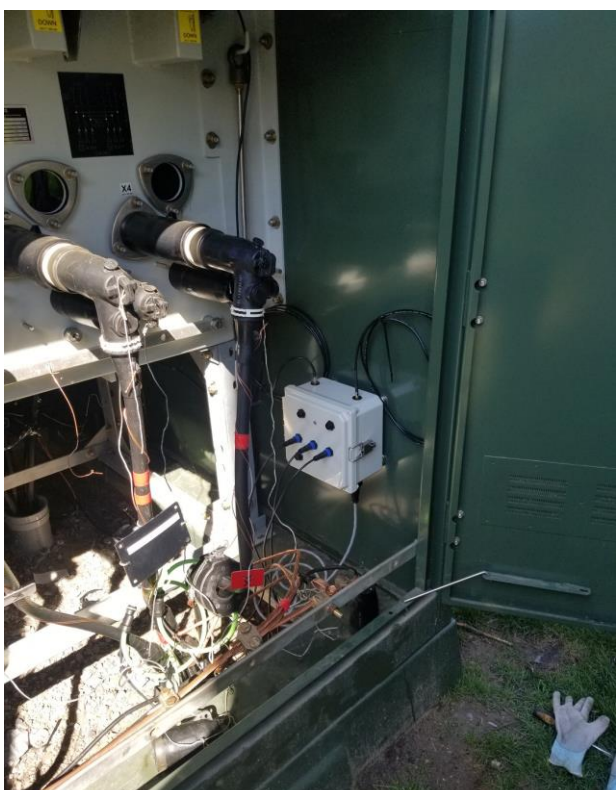
Switchgear Installation

Athena sensors were also installed on switchgear at the Detroit Institute of Art. The sensors were utilizing power harvesting technology

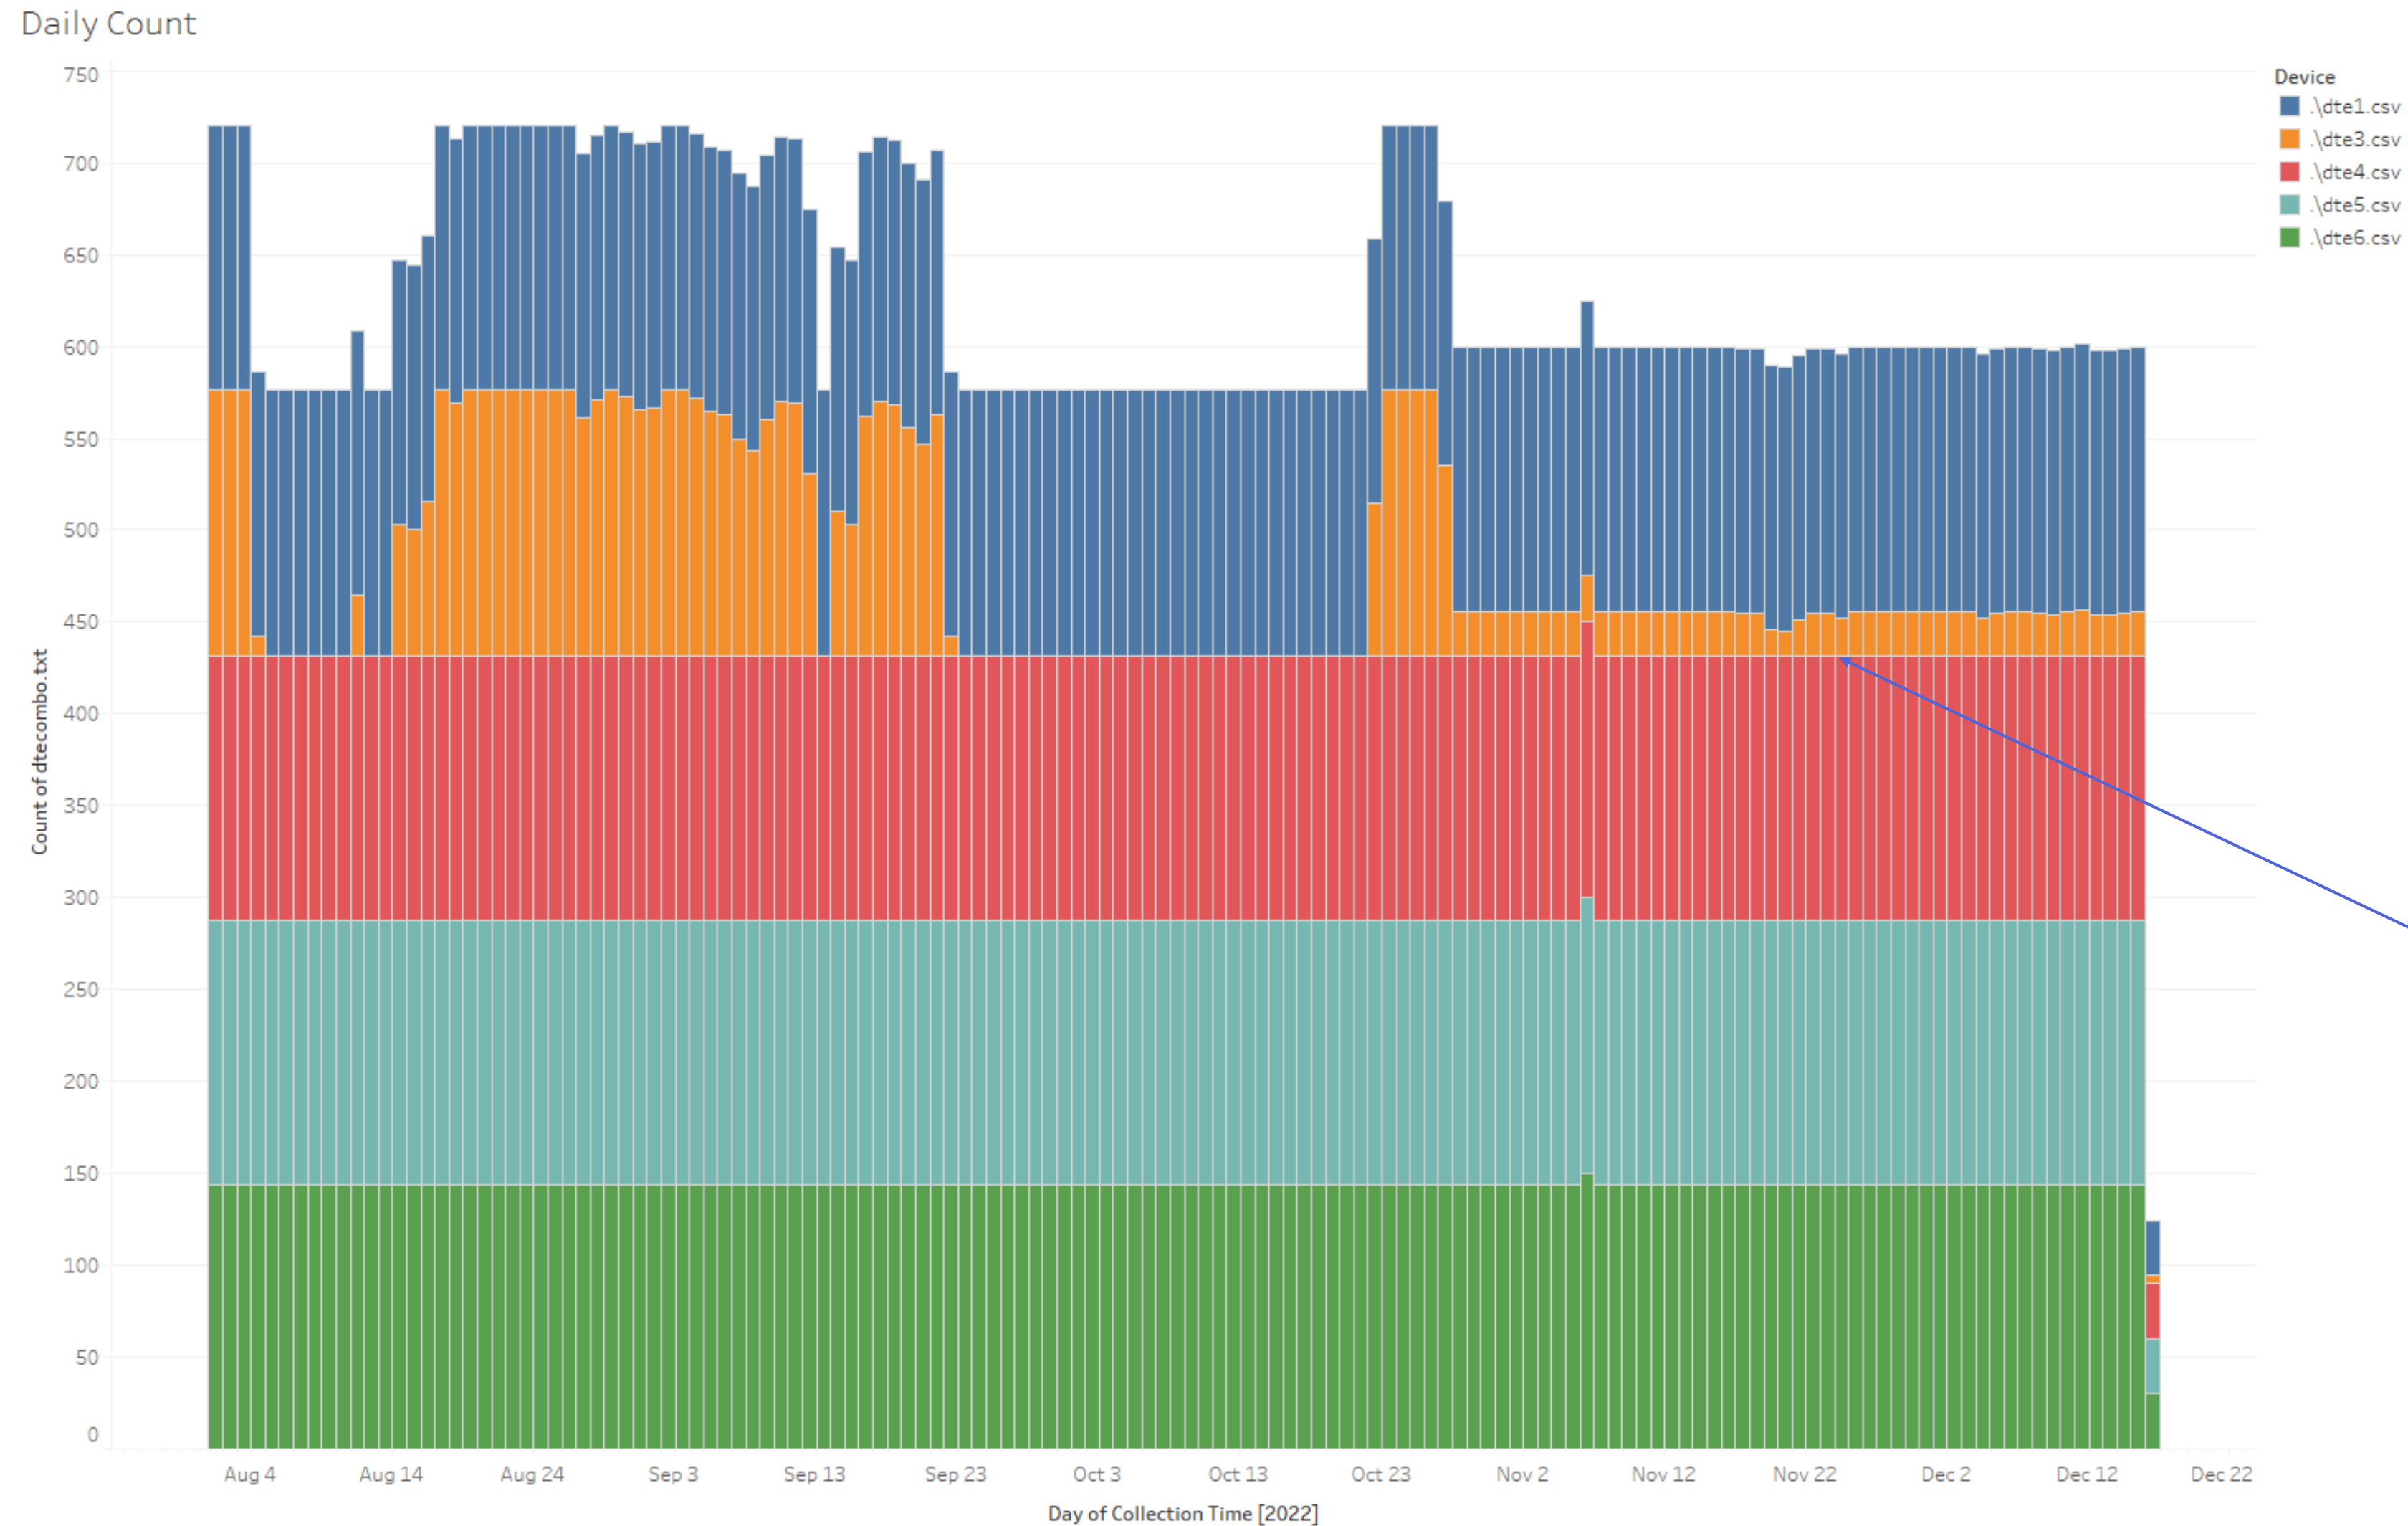
Sensor Daily Count / Collection

- 1) Healthy/Consistent Readings from Netbank UFD sensors
- 2) DTE 3 Sensor (orange) readings have gaps due to inadequate power (periods of below 20amps) from power-harvesting operation of switchgear

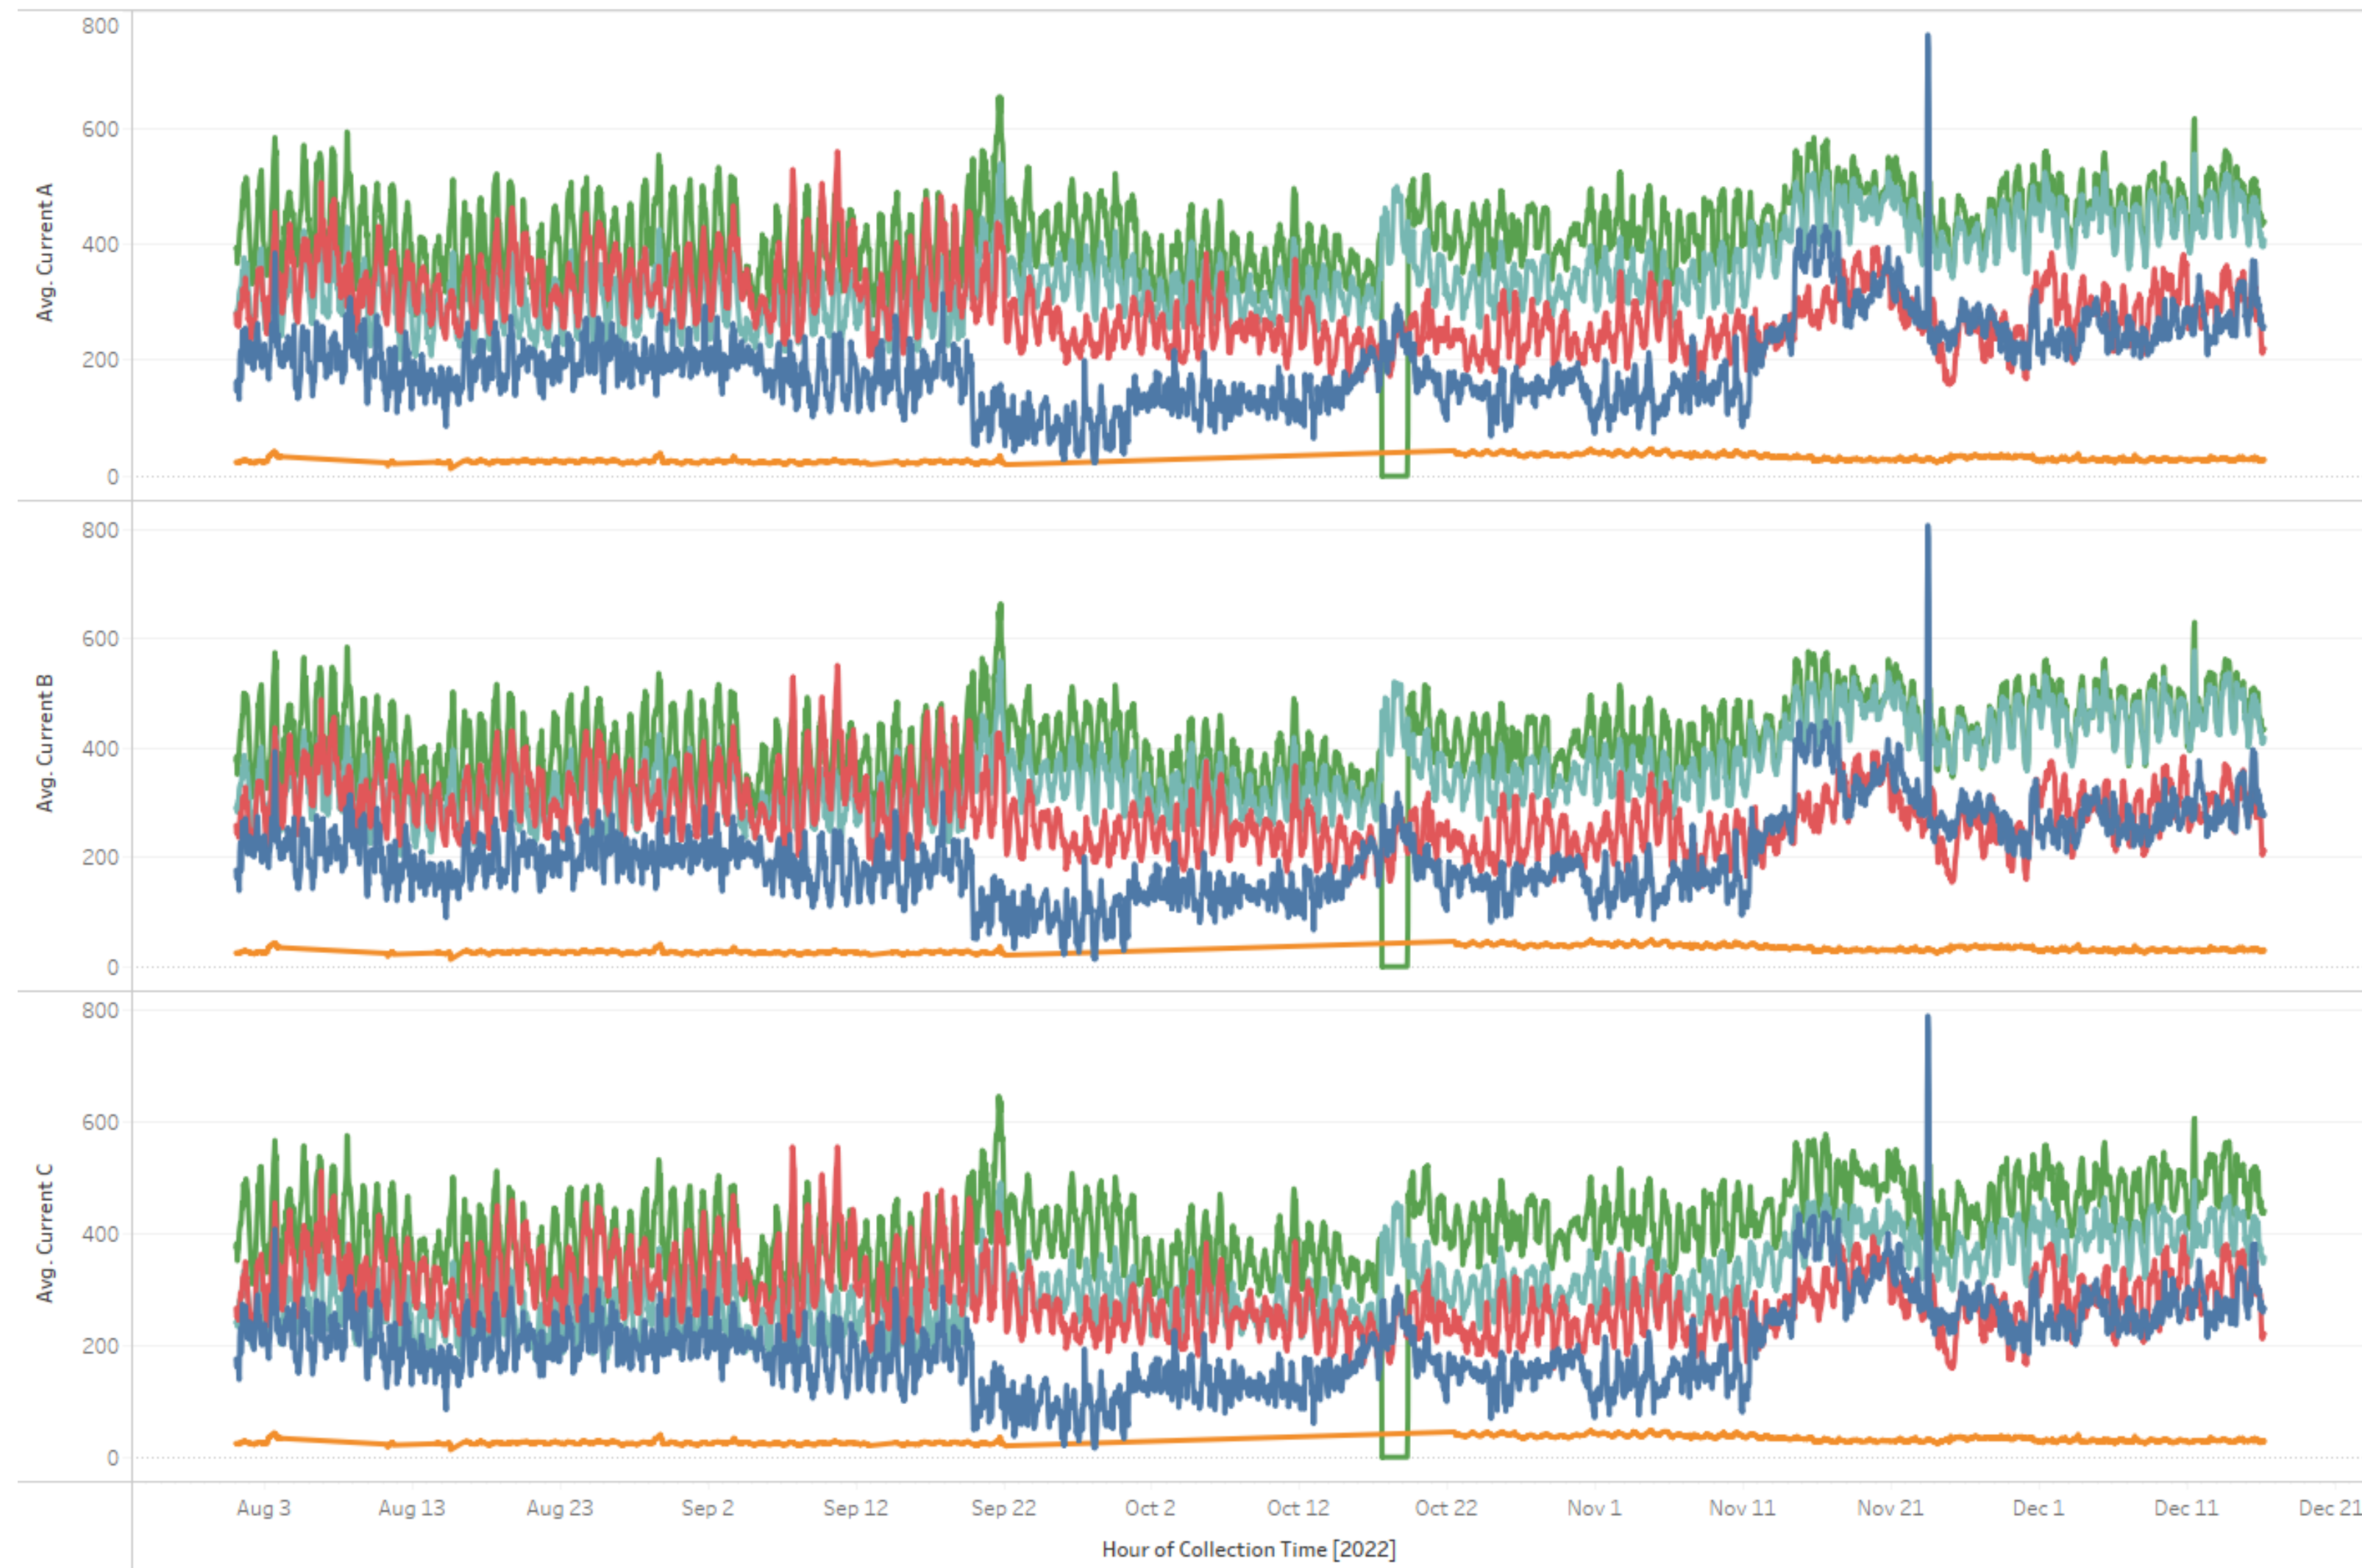
Average Current Trends

- 1) Line Current from Sensor 4 & 6 went up (around Sept 22). Line Current for Sensor 1 went down
- 2) Event driven alarm notifications from sensors were sent due to the following Line Current threshold breaches
 - Sensor 6 detected a major drop in Current back in Oct 17th-19th
 - Sensor 1 detected a major spike in Current in Nov 23rd

The trends of average of Current A, average of Current B and average of Current C for Collection Time Hour. Color shows details about Device. The view is filtered on Device, which keeps .\dte1.csv, .\dte3.csv, .\dte4.csv, .\dte5.csv and .\dte6.csv.

- 1) Athena recommends looking at Netbank NB 757 (Griswold & Grand River) / Sensor 6
 - Such wild fluctuations going down to 58hz could indicate serious problems
 - The frequency is overall drifting lower, compared to other sensor locations is also unusual
- 2) The major drop in Current from Sensor 6 (NB 757) in Oct and the major spike in Current from Sensor 1 (NB 755) in Nov should be further examined
 - Such fluctuations on either side cause erosions and long-term damage to the equipment

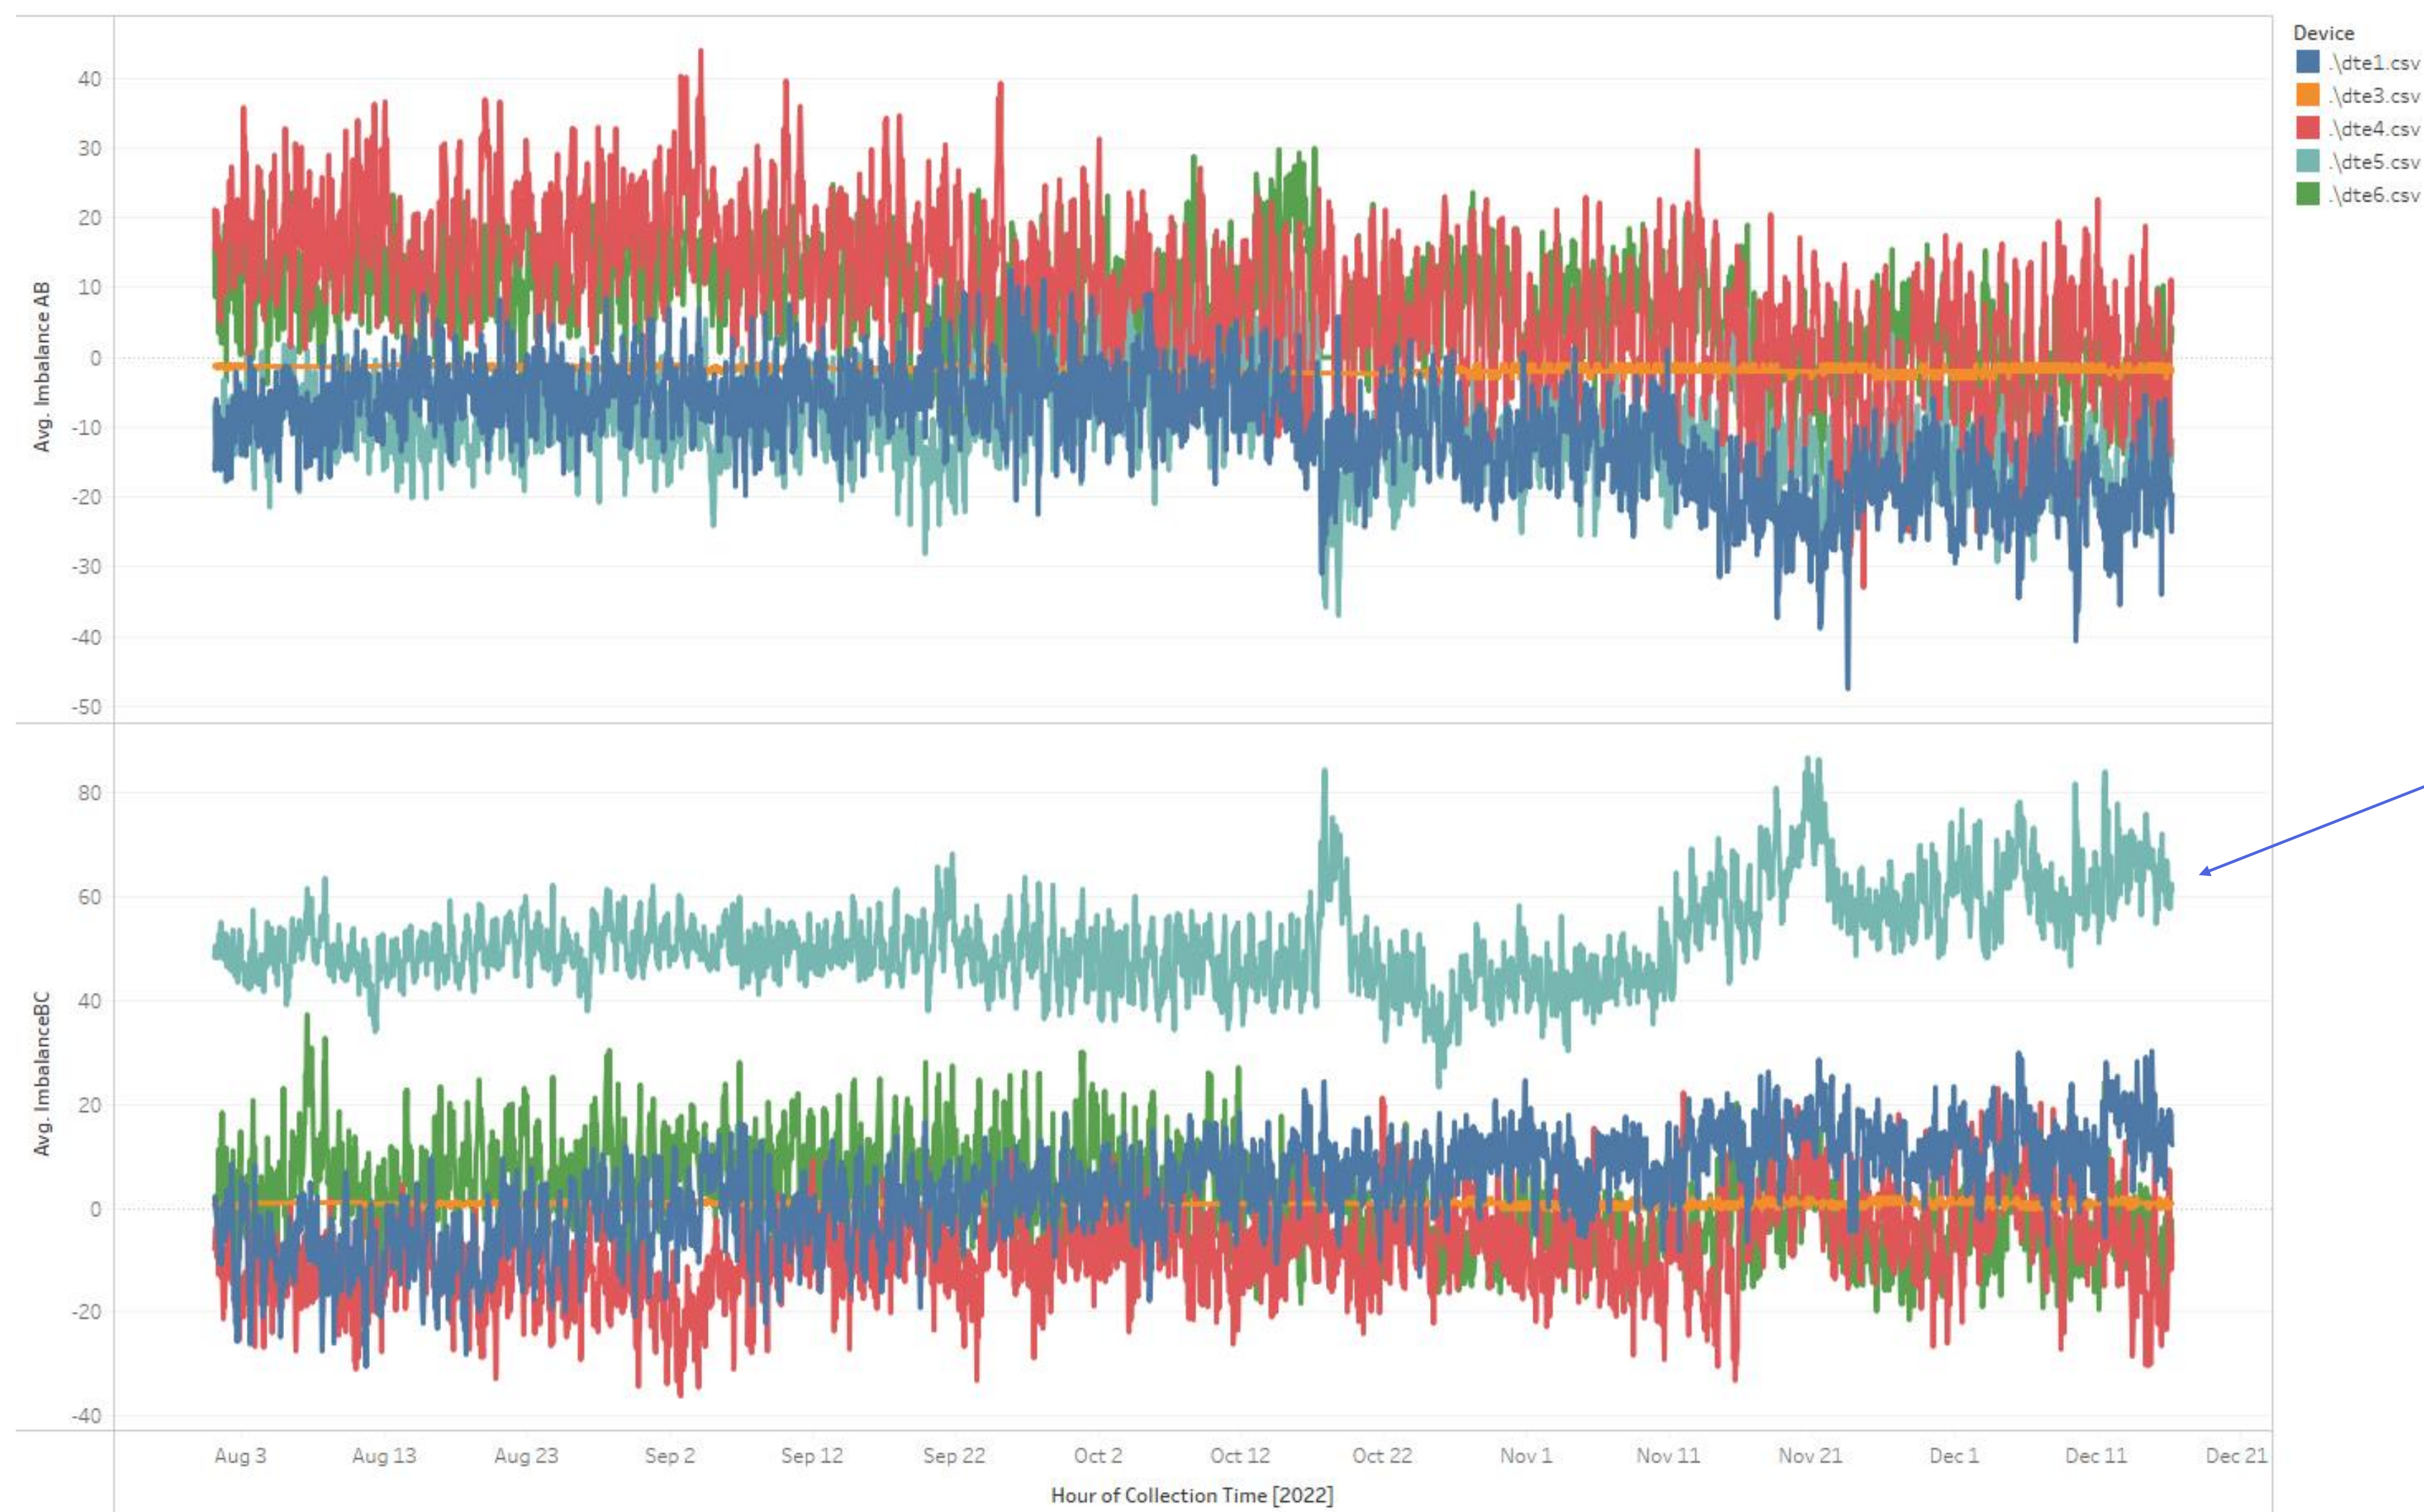
Trends of Average Imbalance

- 1) A to B Phases well-balanced through-out sensor readings
- 2) B to C Phases on Sensor 5 unbalanced, based on readings

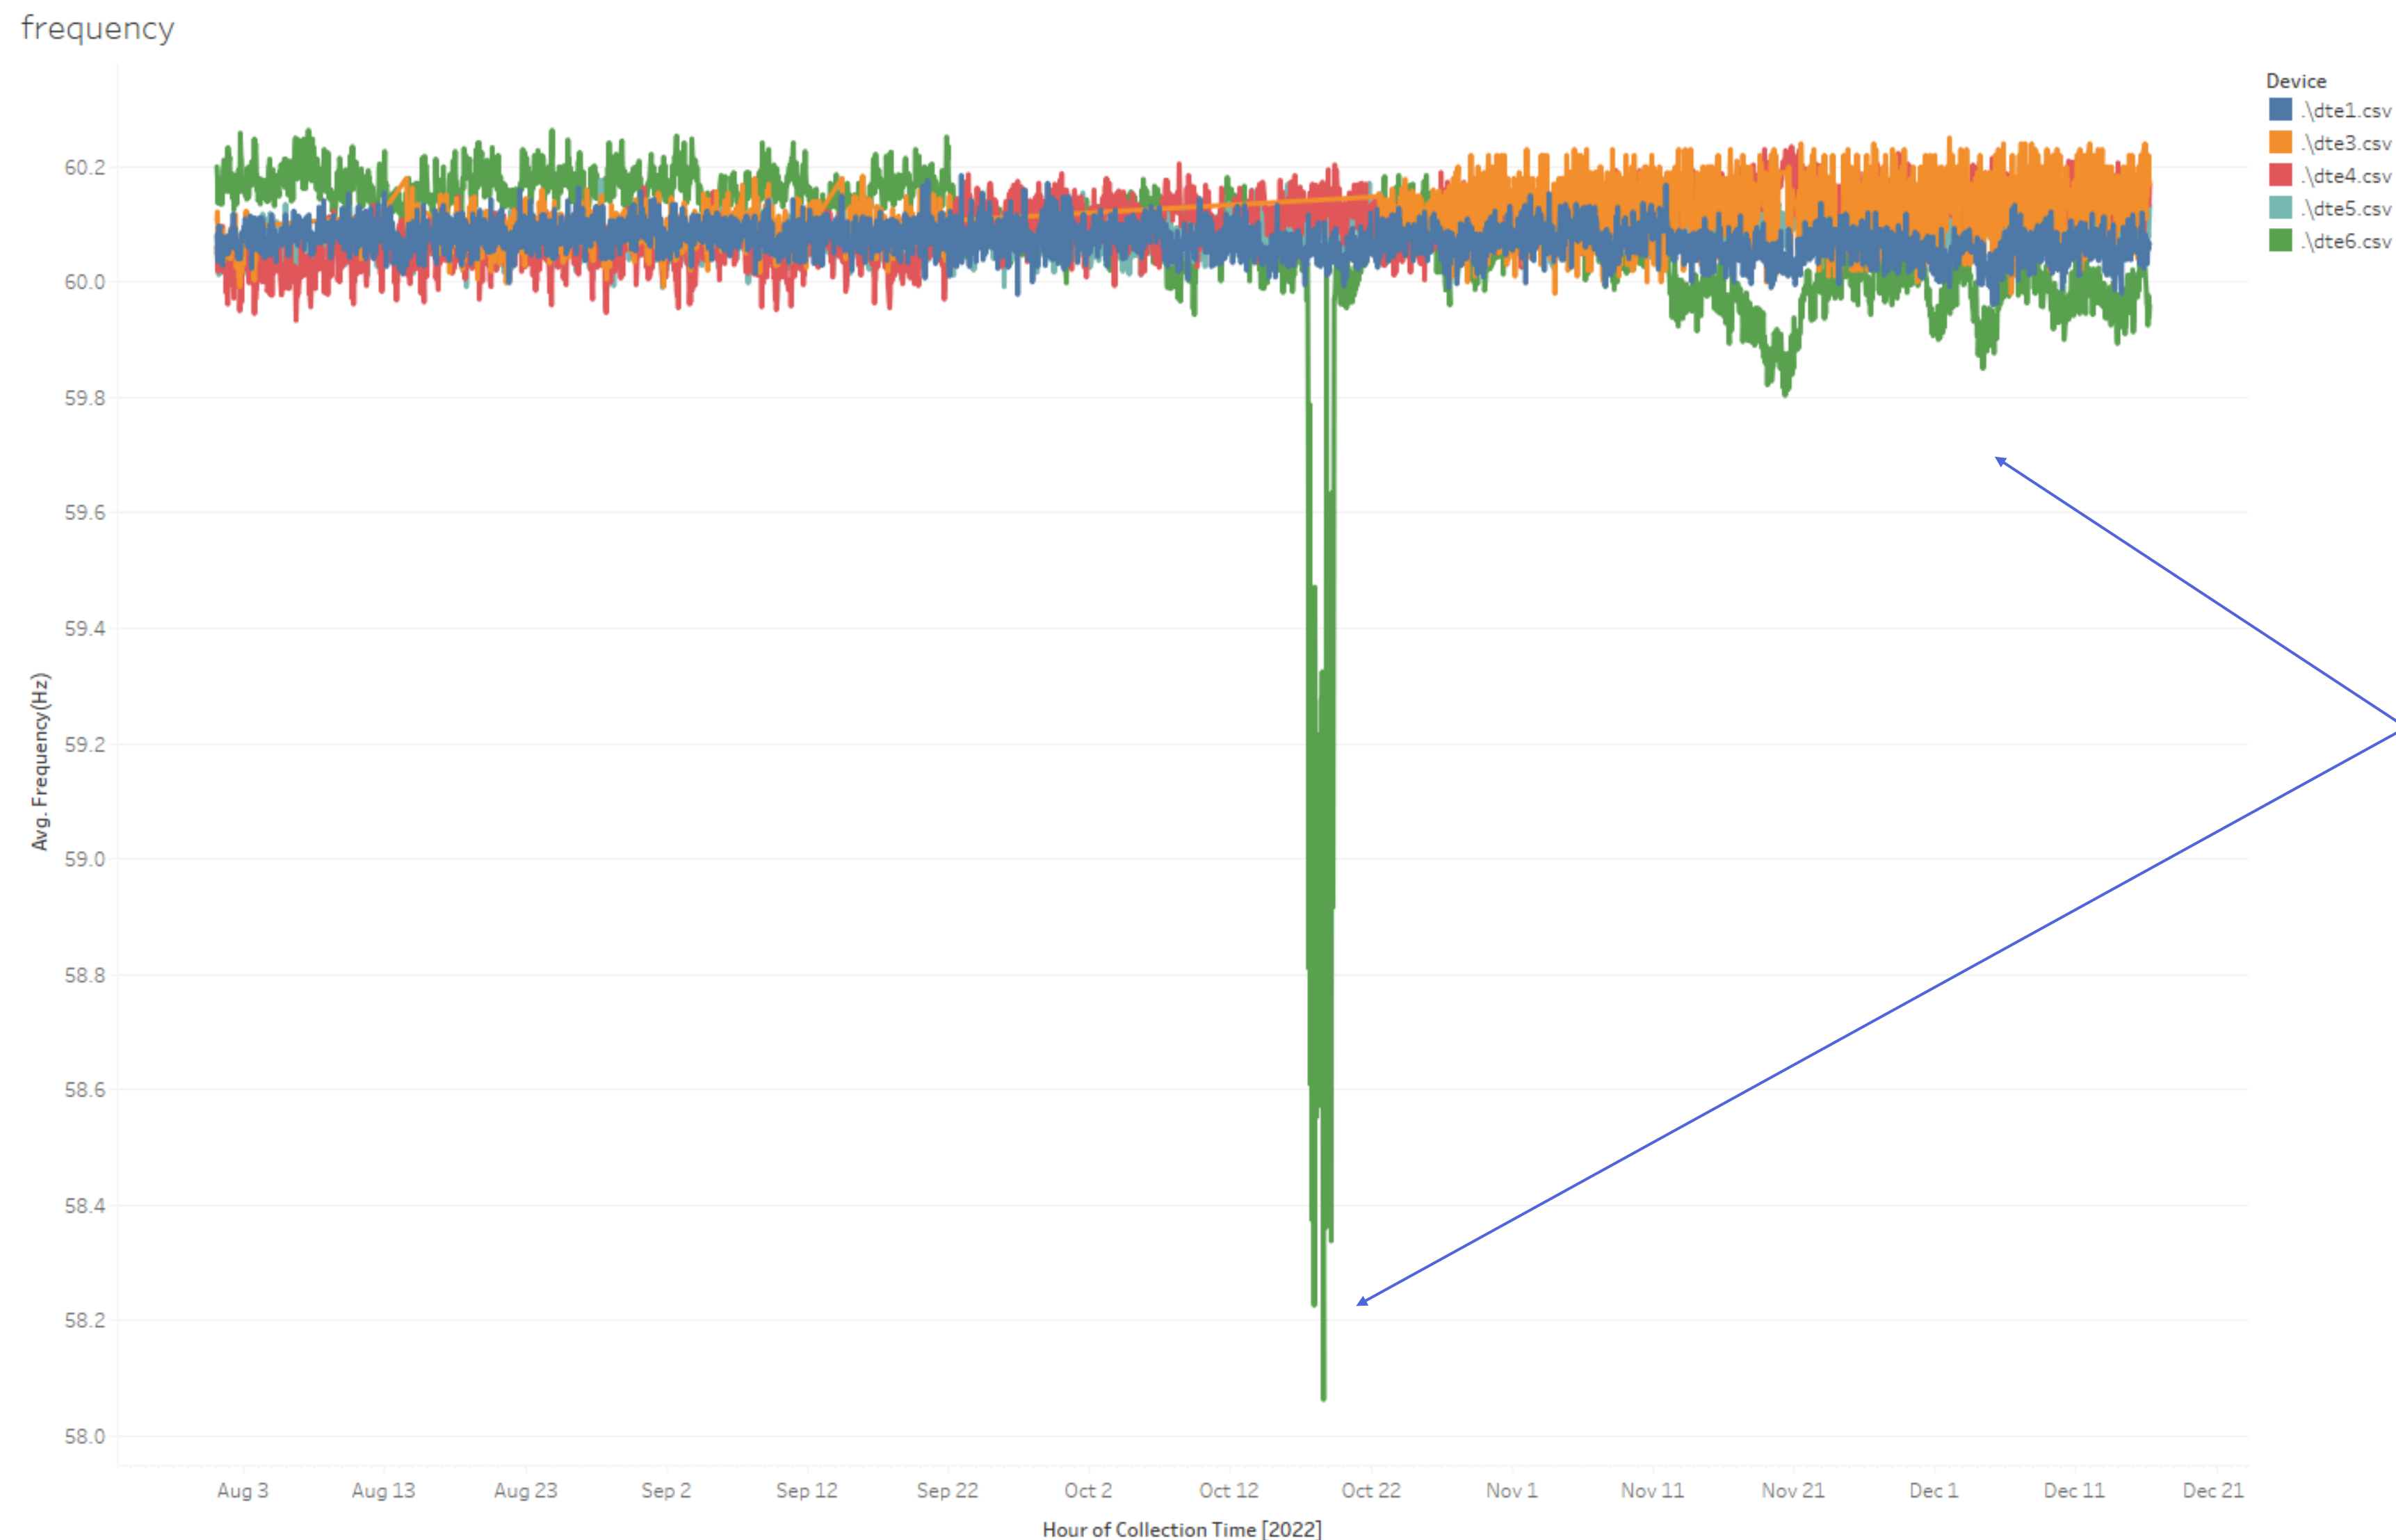
Trends of Average Frequency

- 1) Sensor 6 frequency is low, struggling. See Nov timeframe
 - FREQUENCY SHOULD NEVER BE DOING THIS
 - Harbinger of bad things to come

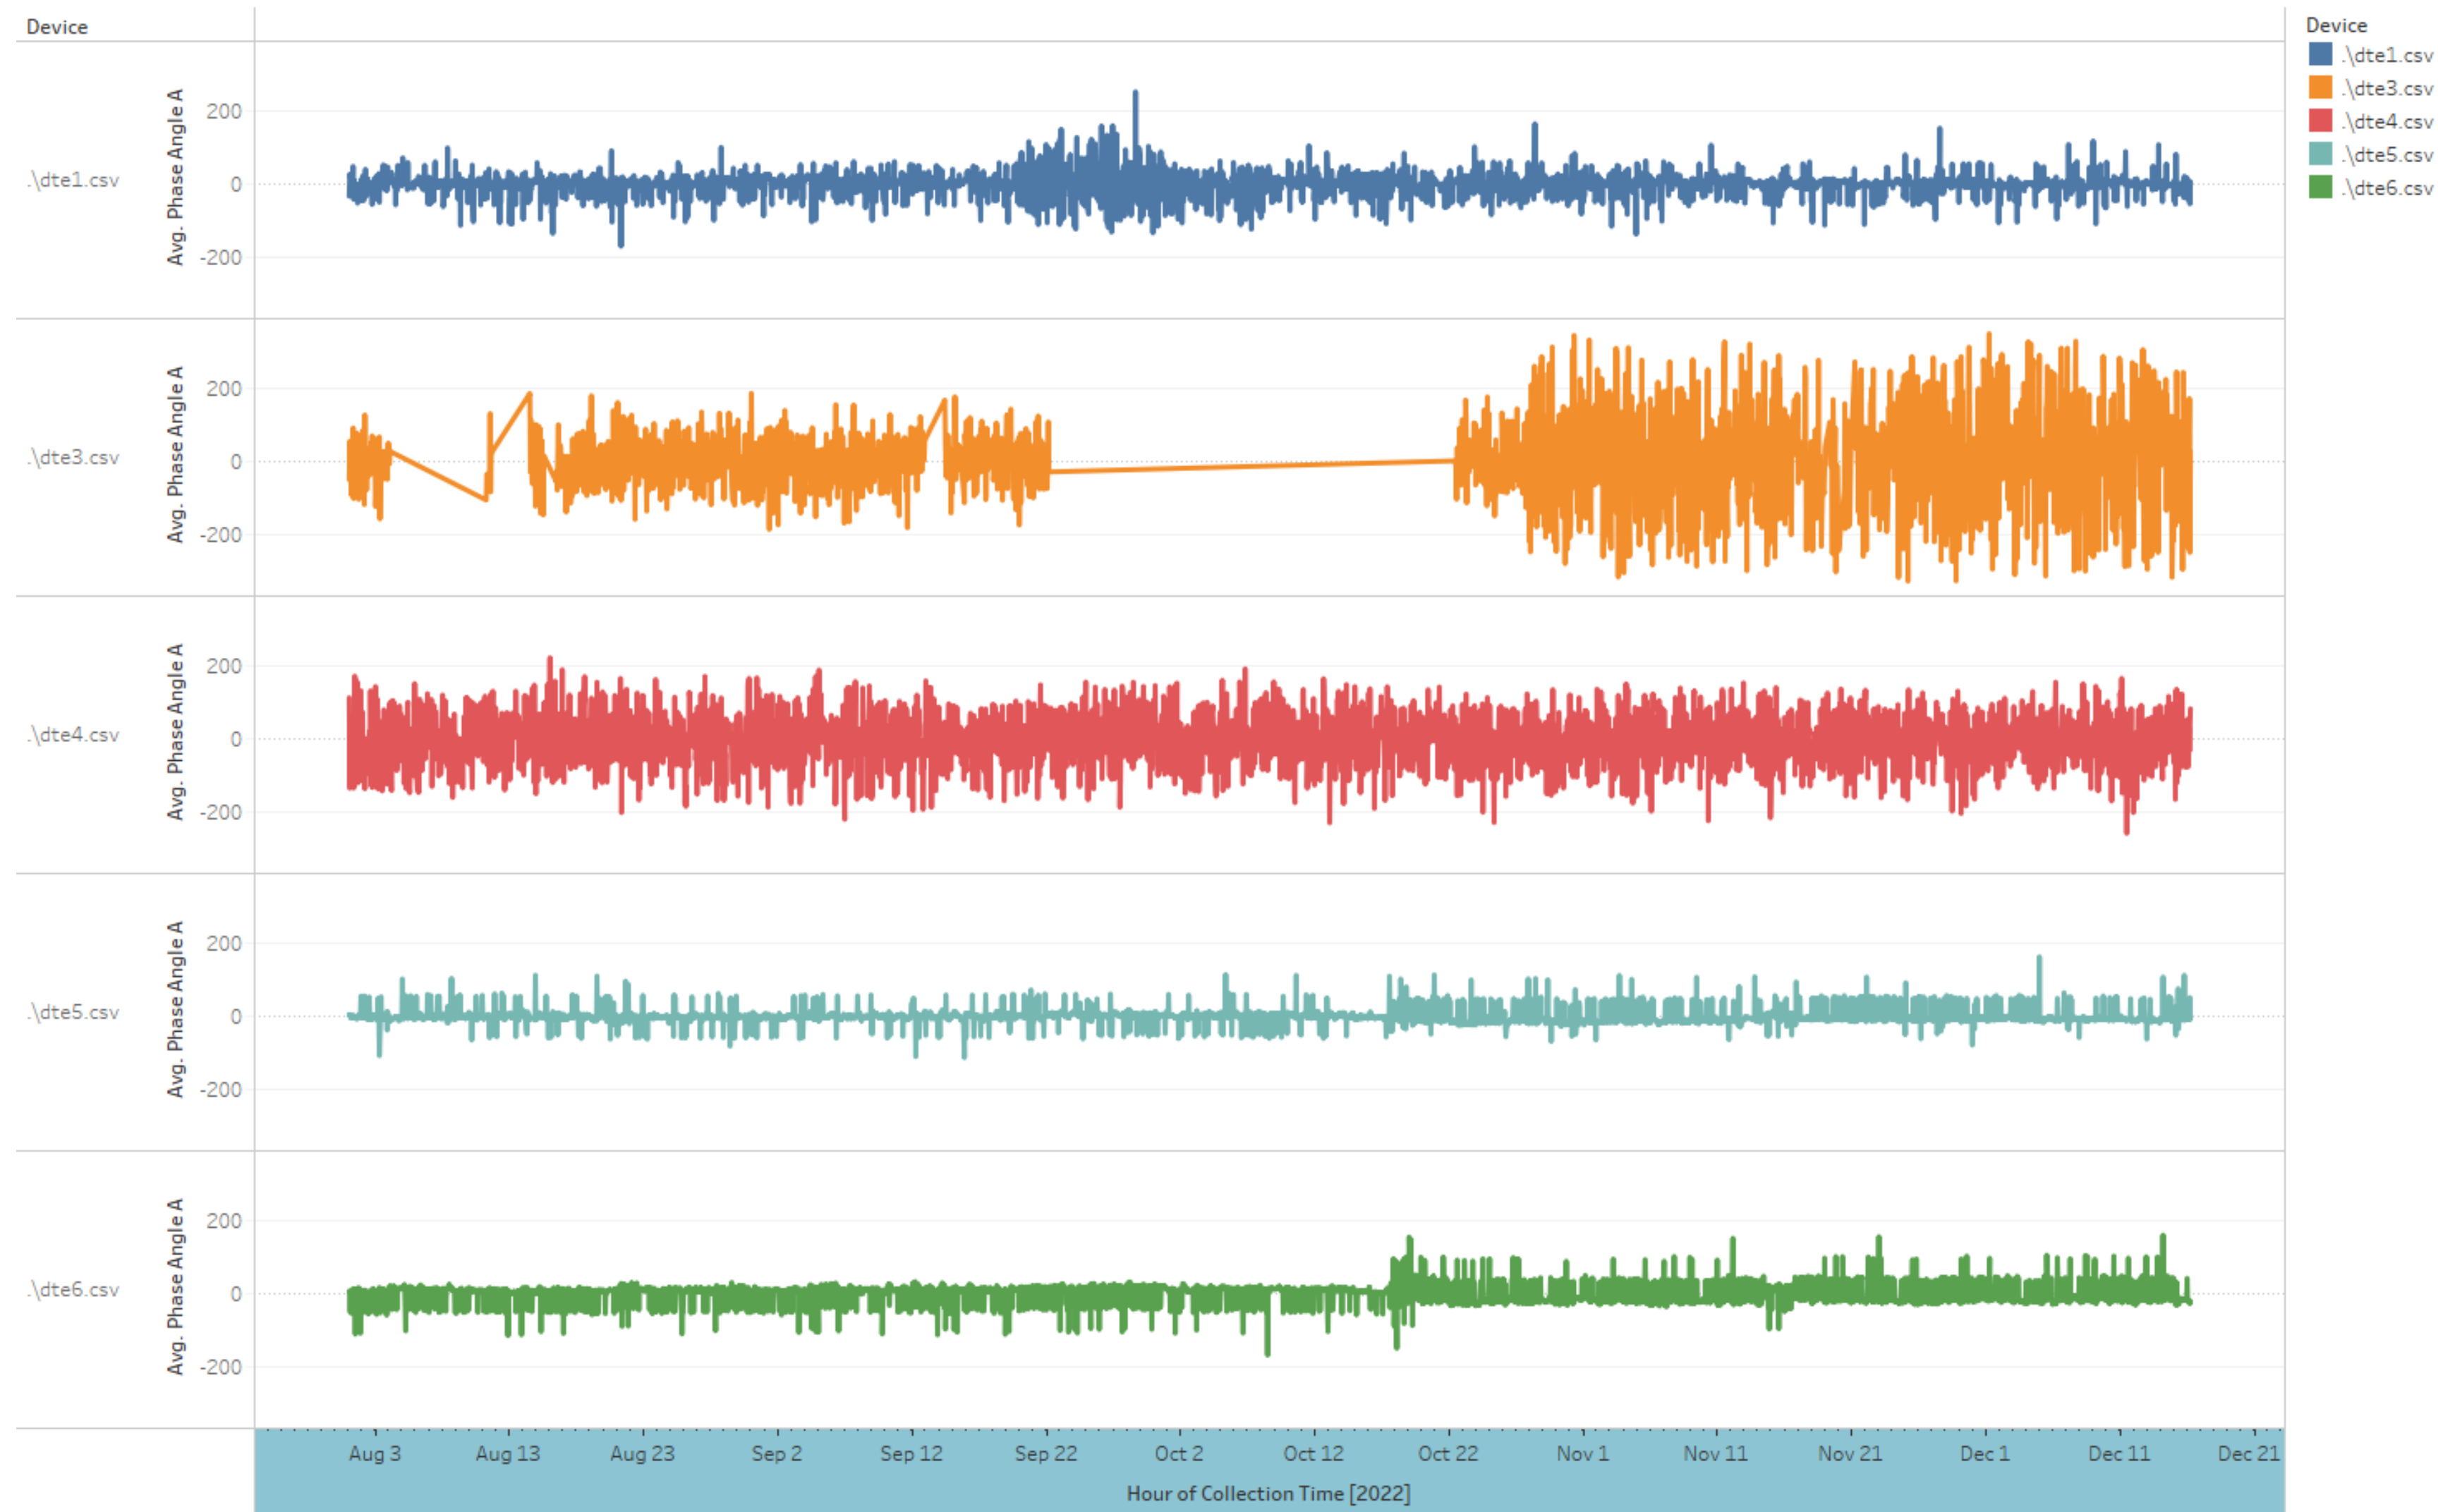
Trends of Average Phase Angle A to B

- 1) No unusual activity in phase angle analysis

The trend of average of Phase Angle A for Collection Time Hour broken down by Device. Color shows details about Device. The view is filtered on Device, which keeps .\dte1.csv, .\dte3.csv, .\dte4.csv, .\dte5.csv and .\dte6.csv.
