ATHENA POWER

Detroit Edison Sensor Pilot
Data Analysis 2022

Pilot Overview

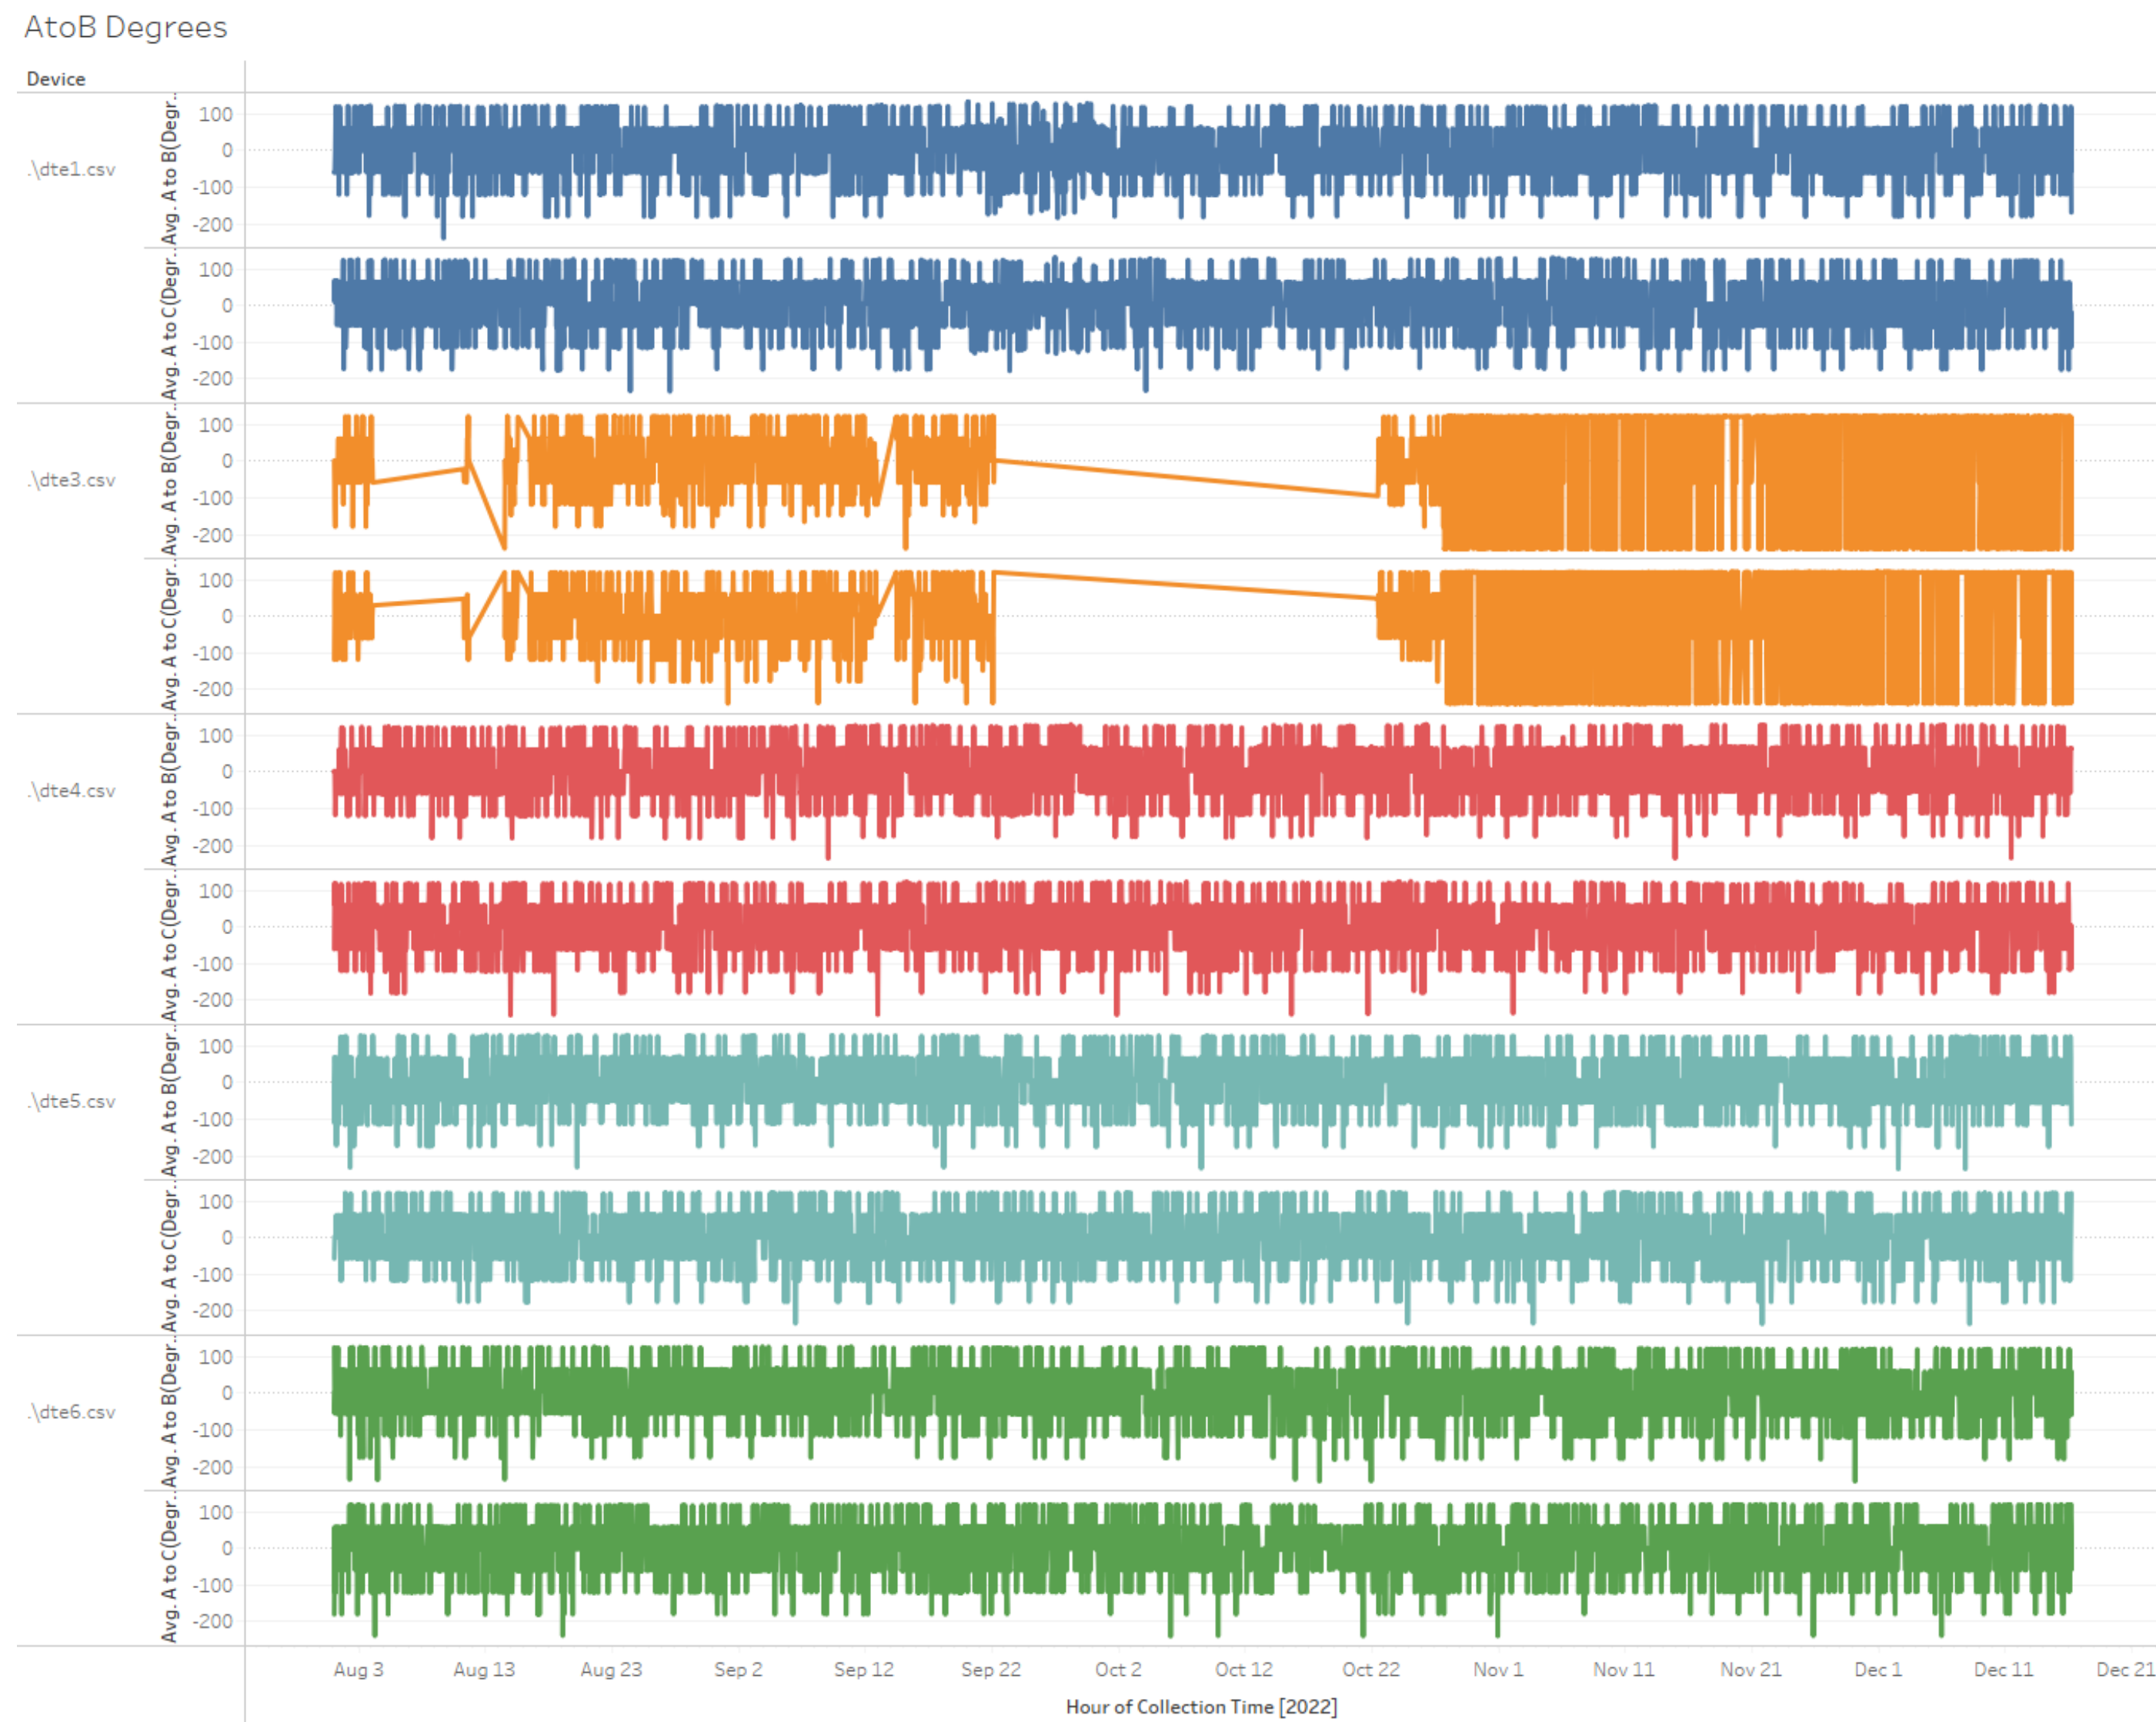
Trends of A to B and A to C

- 1) No unusual activity in phase angle analysis
